# How to Repair Damaged PE-RT Pipe

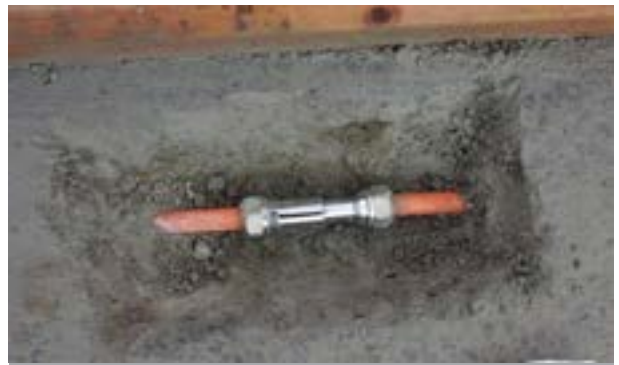
## Option 1:

1x telescopic joint and 2x PE-RT compression fittings. This would then be wrapped in denso tape, pressure tested, and the slab re-filled:

Following the repair of the damaged pipes the system should be put back under pressure test and hold pressure for 24 hours before the exposed pipes can be backfilled. Location of the repairs should be recorded and shown on as-built drawings for future reference. From our experience these repairs will have a long life but are the most likely location for any issues in the future so being easy to locate would be preferable.

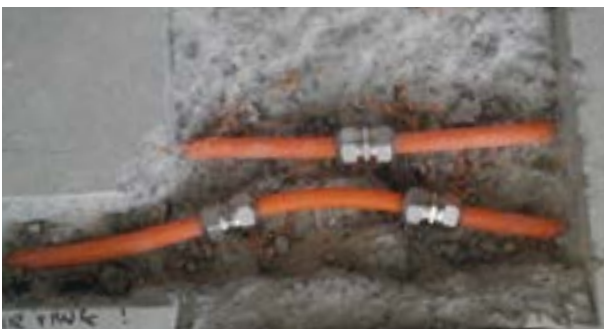
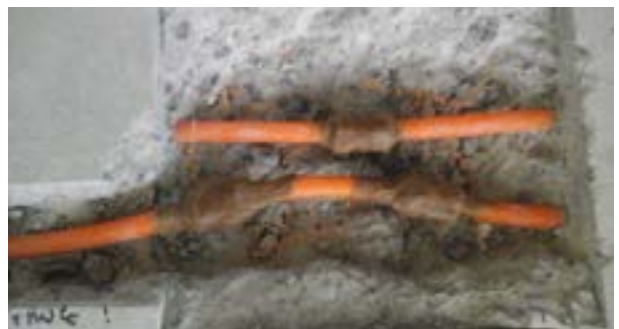
## Option 2:

2x HEX nipples and 4x compression fittings per repair. This would then be wrapped in denso tape, pressure tested, and the slab re-filled.
